1st International Conference on LWR Fuel Performance, Modelling and Experimental Support

Westinghouse LTA inspection at Temelín NPP

Michal Kuna, Jan Höglund
Westinghouse Electric Sweden

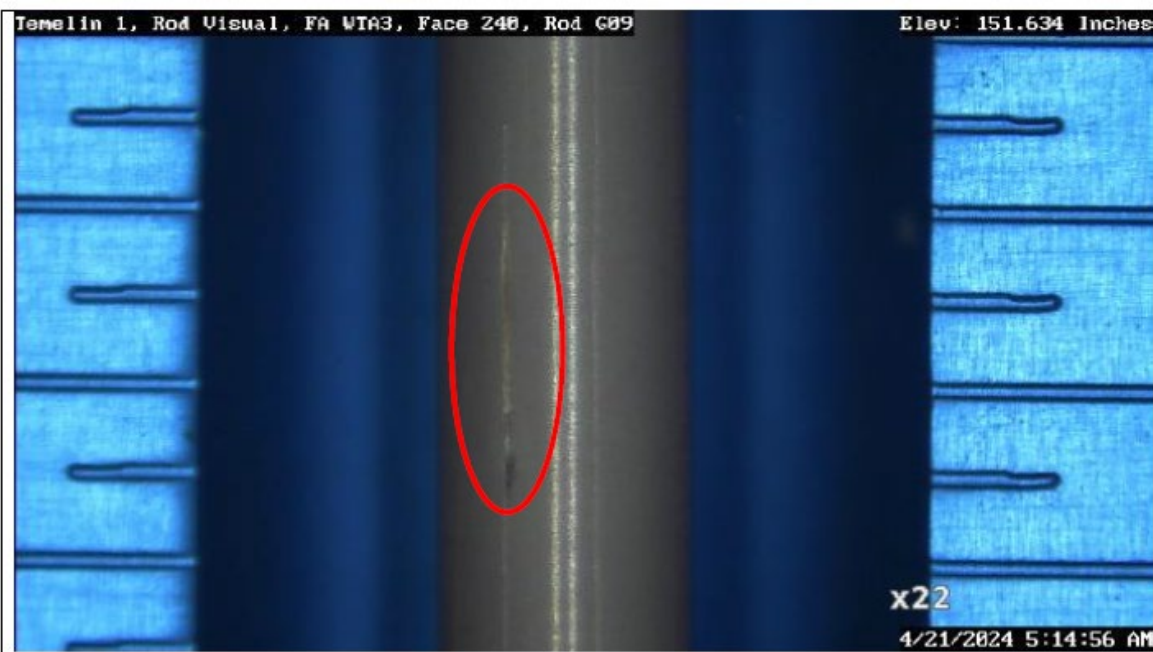
Contact mark and scratch from rod extraction, rod G09

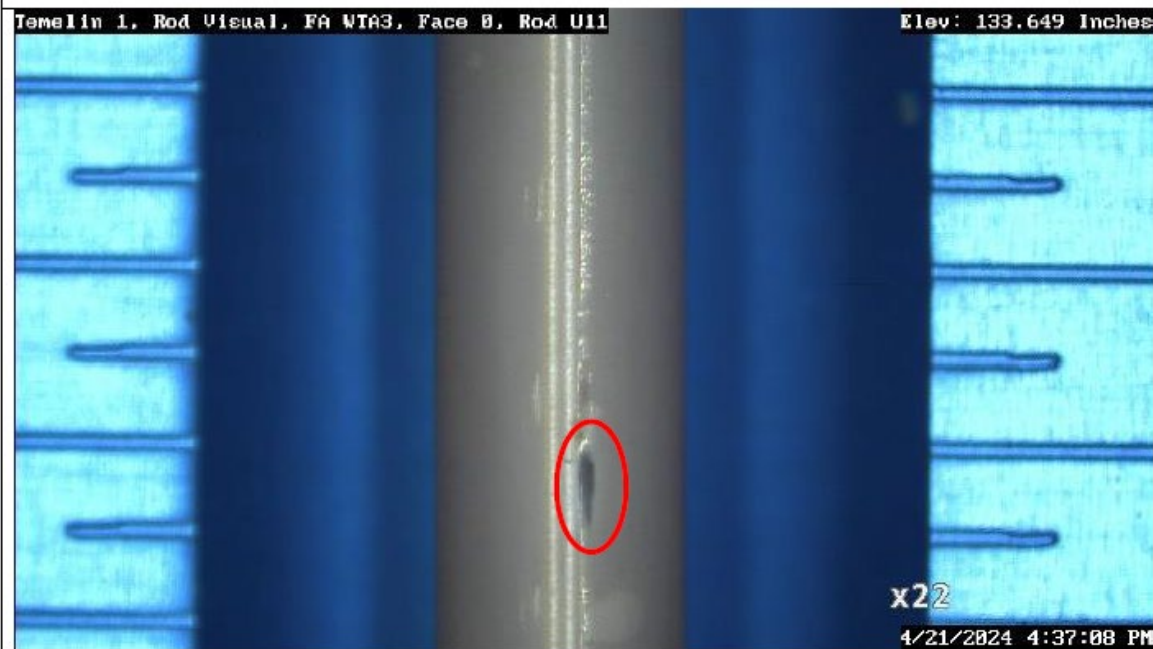
Contact mark on rod U11

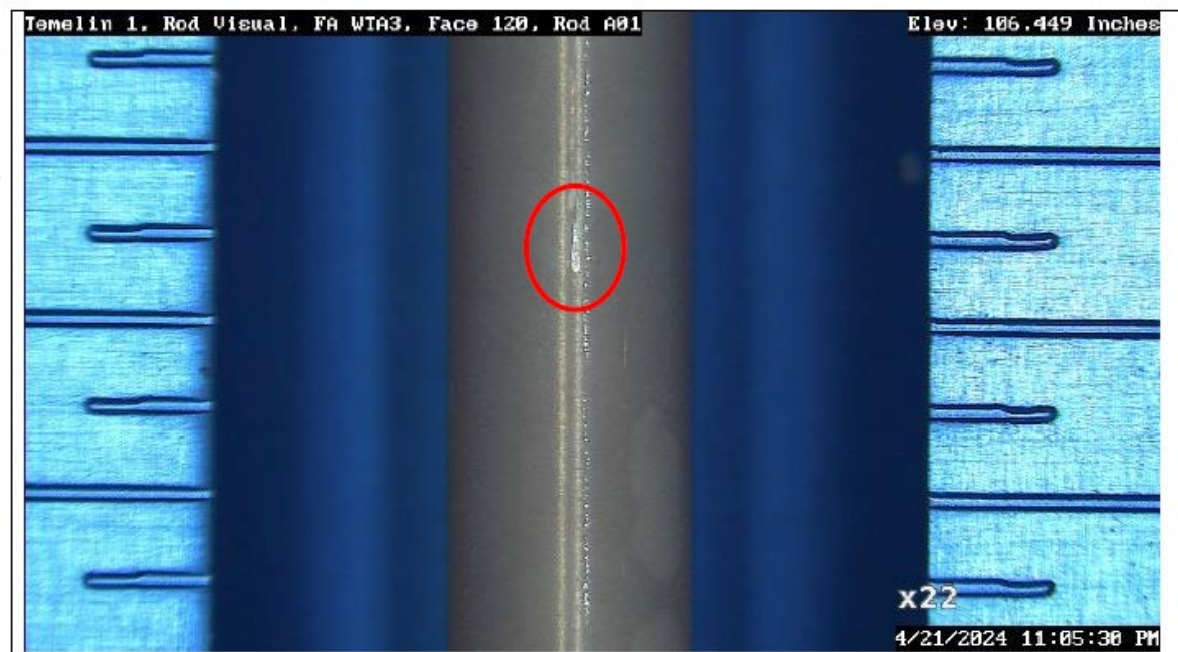
Typical contact marks on rod A01

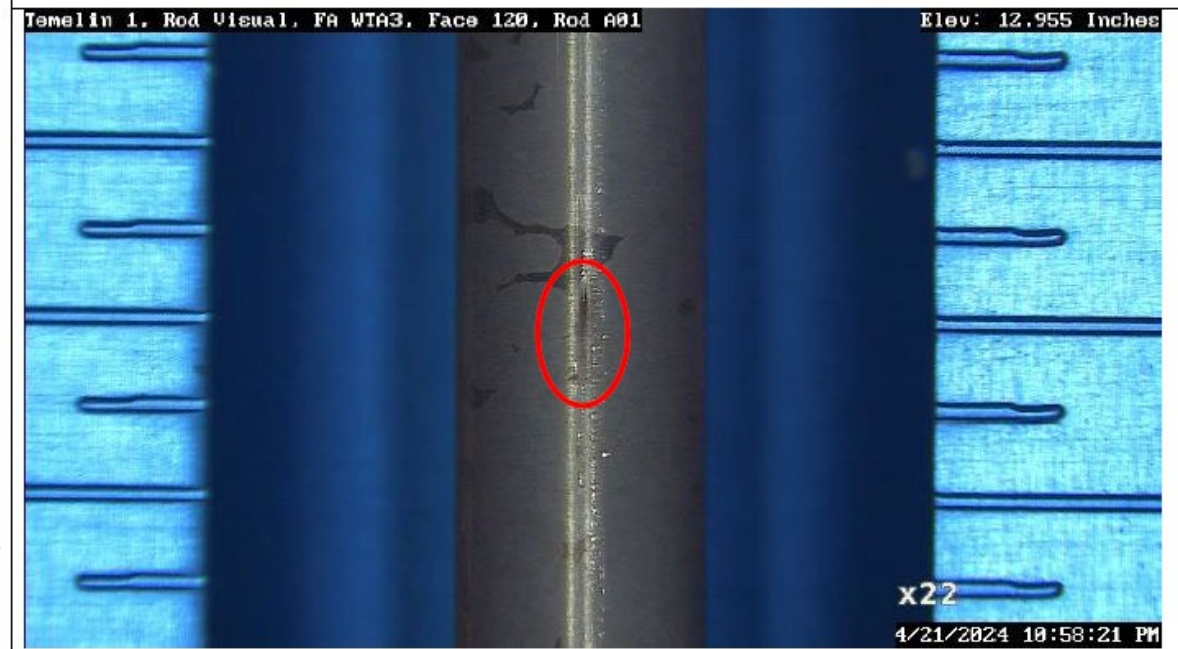
Typical contact marks on rod A01

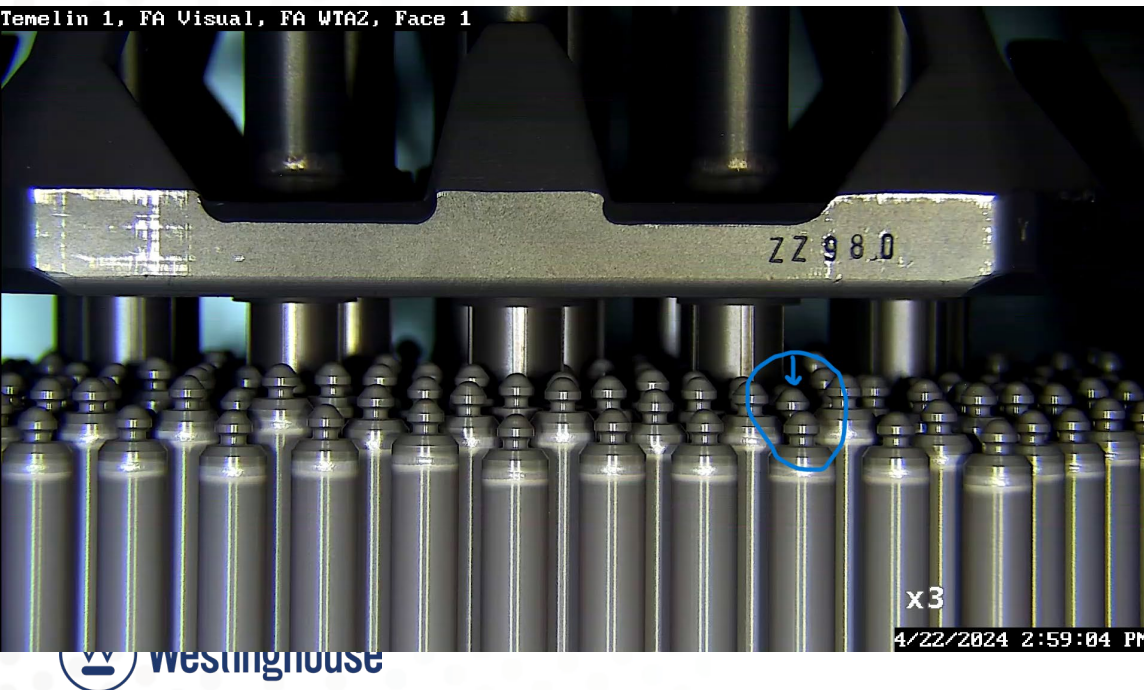
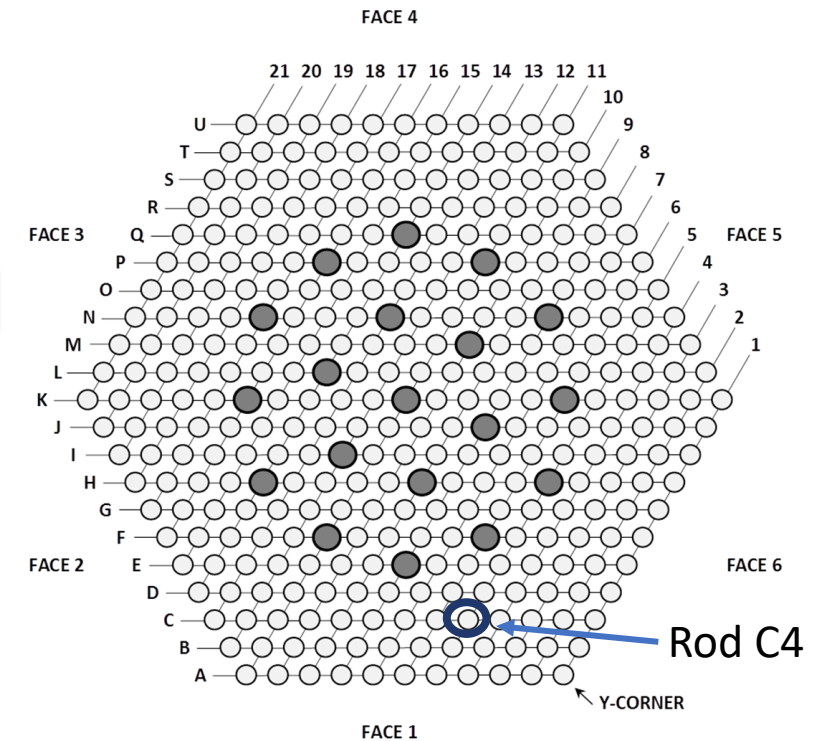
AFIS Inspection on the Leaking WTA2

- Rod C4 detected as leaking
- No excessive growth
- Difficult to visually inspect in third row

- One leaking FR identified
- No excessive growth observed
- Root cause not established
