1st International Conference on LWR Fuel Performance, Modelling and Experimental Support

Westinghouse LTA inspection at Temelín NPP

Michal Kuna, Jan Höglund
Westinghouse Electric Sweden

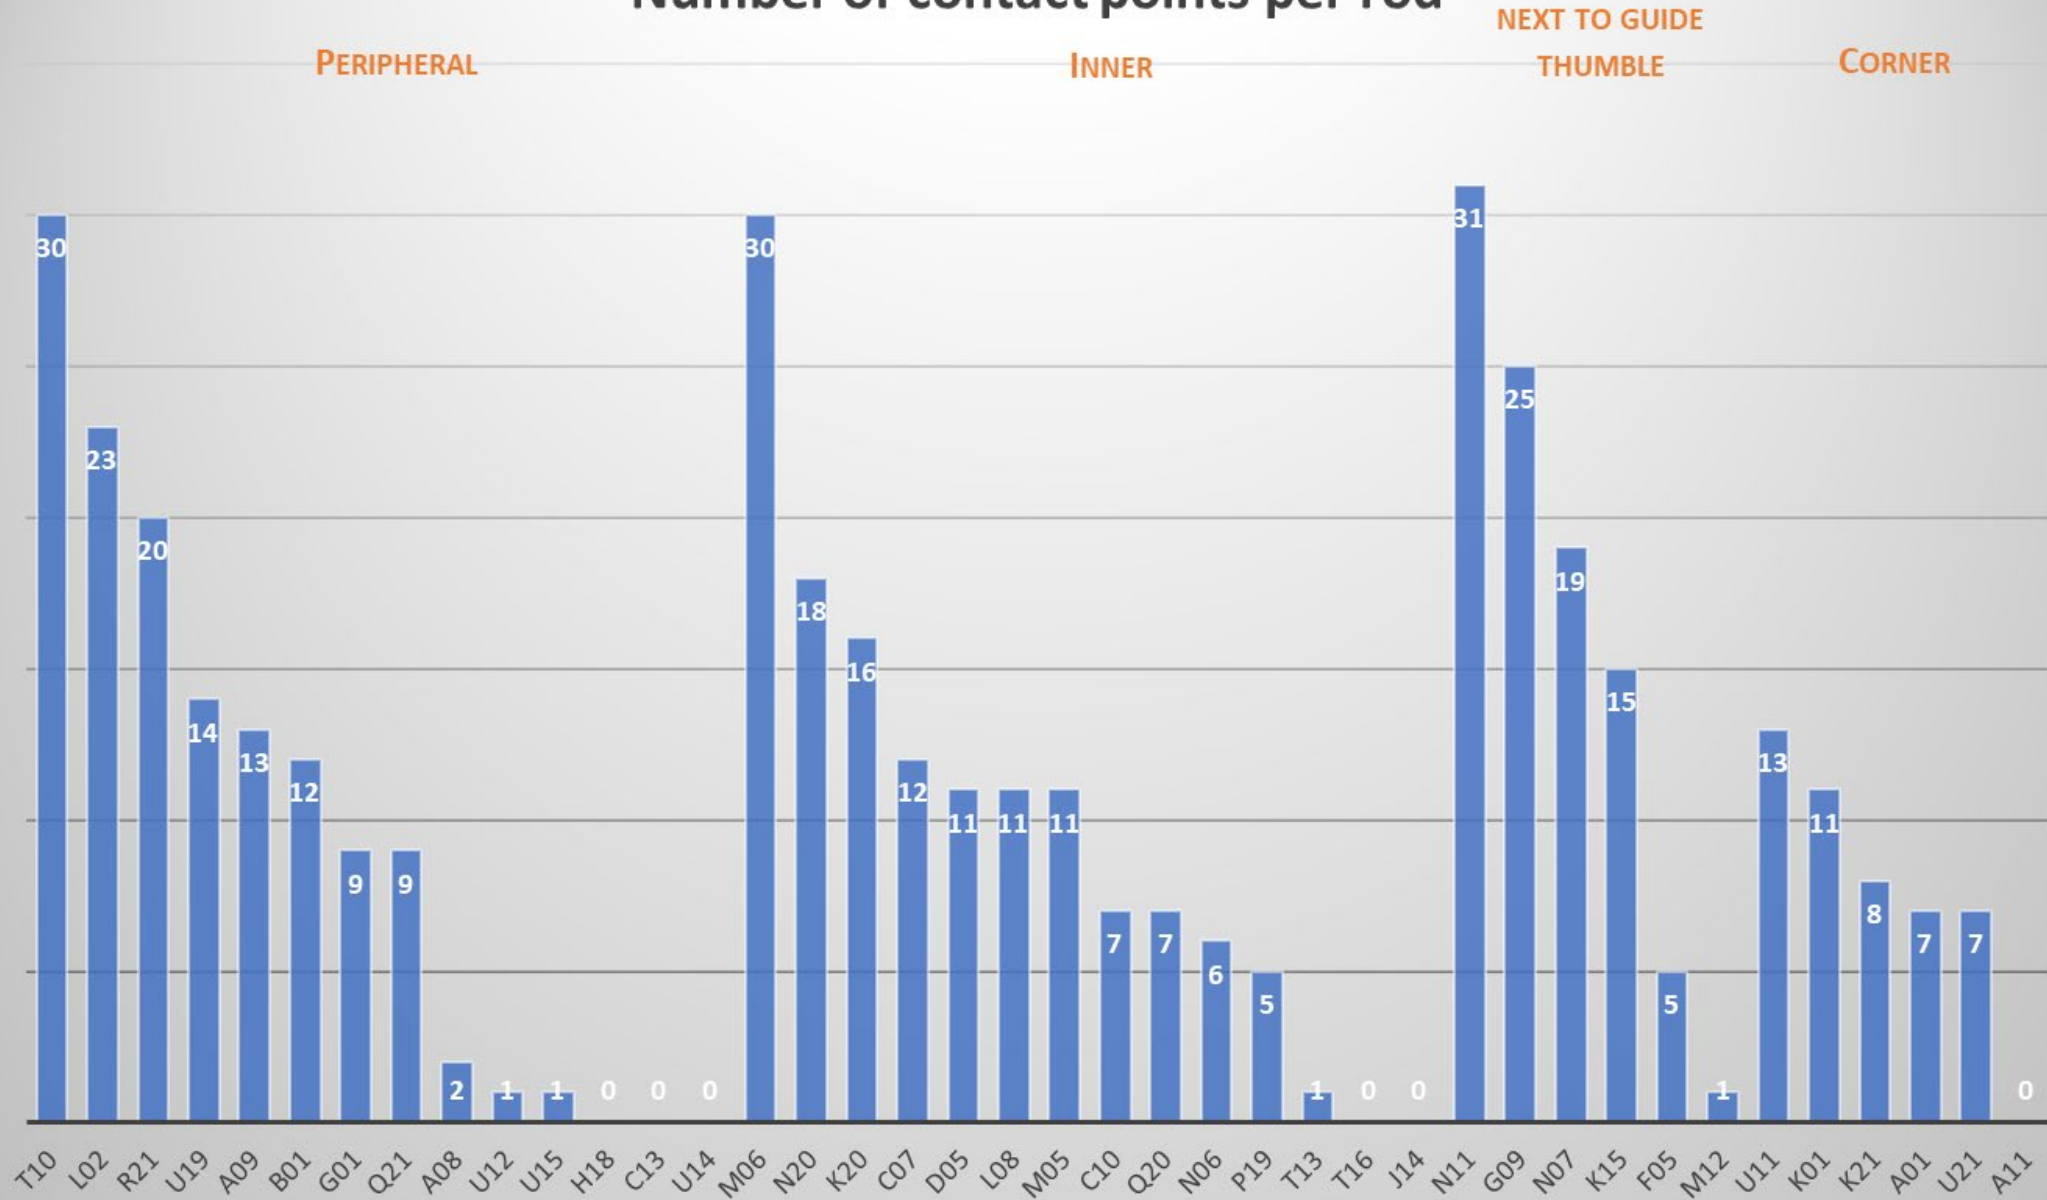
- 40 rods, 13 grids, 1+2 spring/dimples per cell → **1560 contact positions** inspected
- **No fretting wear observed.** Only normal contact marks

Number of contact points per rod
